Blue Tree Home Inspection LLC
123 Somewhere Street
Somewhere, US 12345
(209)769-0483
www.BlueTreeHomeInspection.com

Home Inspection Report

1234 School House Road
Yourtown, US 12345

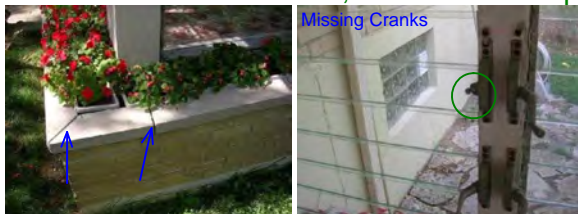
- 5. Marginal Patio/Enclosure: Ceramic tile, Brick, Aluminum windows - Loose limestone wall caps, Missing screens and some cranks, Lubricate as required

3. Patio/Enclosure: Ceramic tile, Brick, Aluminum windows - Loose limestone wall caps, Missing screens and some cranks, Lubricate as required

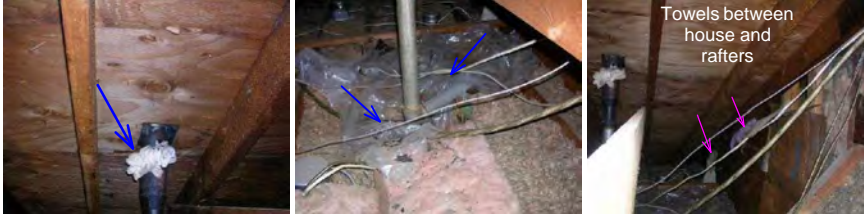
Moisture Penetration: (continued)

- 17. Acceptable Insulation: Fiberglass
- 18. Marginal Insulation Depth: 3" - 10" - **Recommend additional insulation be installed**
- 19. Acceptable Wiring/Lighting: 110 VAC lighting circuit
- 20. Marginal Moisture Penetration: Previous water penetration noted - **Previous water penetration noted at plumbing stack penetration with plastic in attic to catch water and towels wedged between house and rafter- no current leaking detected - Monitor**

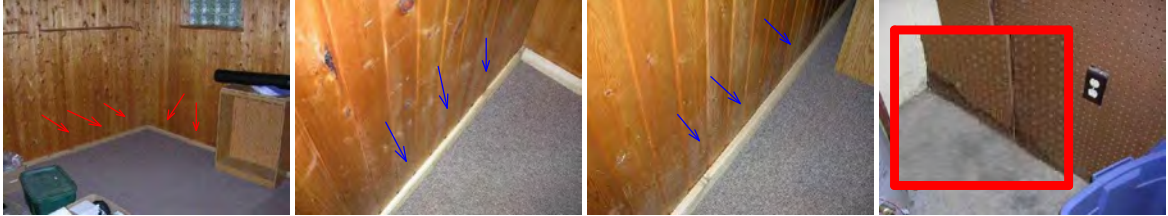
Moisture Evidence: (continued)

- 9. Not Present Sump Pump:
- 10. Defective Moisture Evidence: Note - Suspected mold present along perimeter finished walls at left and rear elevations. Further investigation behind finishes may uncover hidden problems not visible in this visual inspection. Mold conditions can cause acute and chronic health concerns and should be remediated. Corrections may include remediation protocols provided by an environmental hygienist for the suspected mold conditions and qualified remediation contractors to make required corrections.

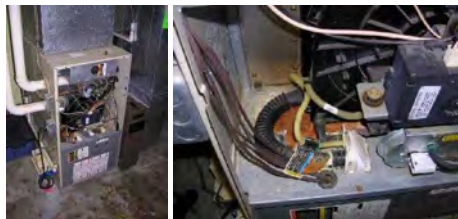
1. Defective Heating System Operation: Note: - **Non-functional at time of inspection, A qualified HVAC technician is recommended to review and correct as required, Condensation leaking stains noted in cabinet**

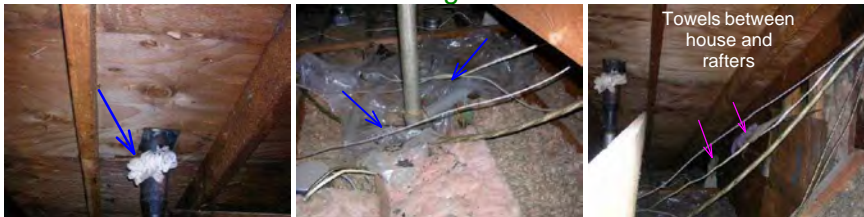
11. Partial house-Lower Attic Insulation Depth: 3" - 10" - **Recommend additional insulation be installed**
12. Partial house-Lower Attic Moisture Penetration: Previous water penetration noted - **Previous water penetration noted at plumbing stack penetration with plastic in attic to catch water and towels wedged between house and rafter- no current leaking detected - Monitor**

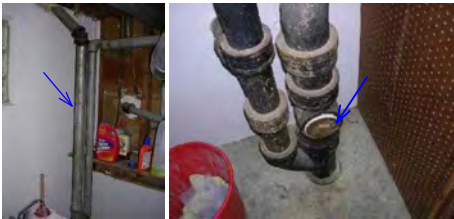
16. Basement Heating System Humidifier: Honeywell - **Not functioning Plumbing**
17. Drain Pipes: Cast iron, Galvanized - **Slow draining noted at Tub. A licensed plumber is recommended to evaluate and estimate corrections, Galvanized drainpipe present- Galvanized piping corrodes from inside causing decreased flow rates and will eventually require updating. Noted new clean out cap which may indicate access was needed to clear drain clog**

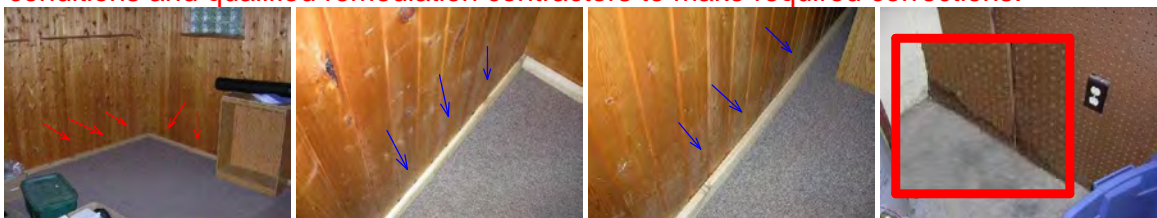
6. Main Basement Moisture Evidence: Note - **Suspected mold present along perimeter finished walls at left and rear elevations. Further investigation behind finishes may uncover hidden problems not visible in this visual inspection. Mold conditions can cause acute and chronic health concerns and should be remediated. Corrections may include remediation protocols provided by an environmental hygienist for the suspected mold conditions and qualified remediation contractors to make required corrections.**

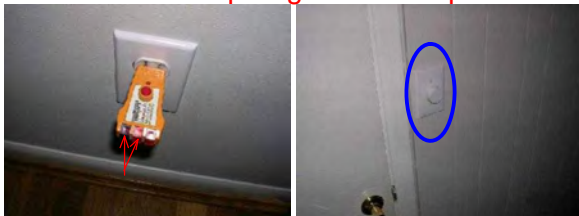
14. Lower Level Living Space Electrical: 110 VAC - **Faulty operation at light dimmer switch-repair, Open ground exists at several 3prong outlet receptacles**

Lower Level Living Space Electrical: Faulty operation at light dimmer
switch-repair
